**The Bahamas
Maritime Authority**

“mv Sea Spirit”

**Report of the investigation into the capsizing of a zodiac craft and
passenger fatality at Fjortende, Juli-Bukta Norway on the
17th June 2013**

Date of Issue: 10th February 2014
Bahamas Maritime Authority
120 Old Broad Street
LONDON
EC2N 1AR
United Kingdom

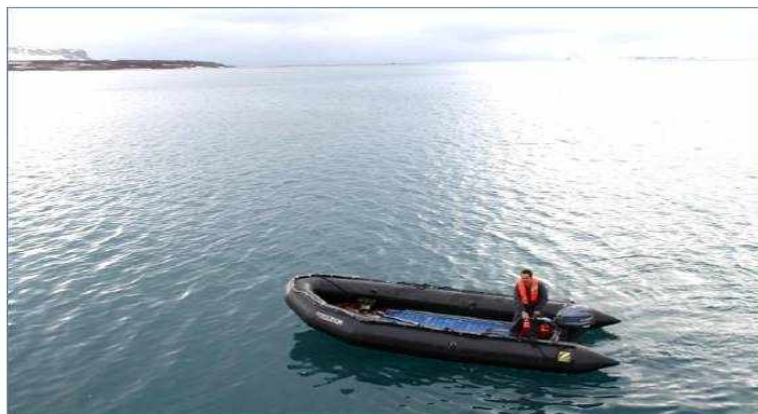
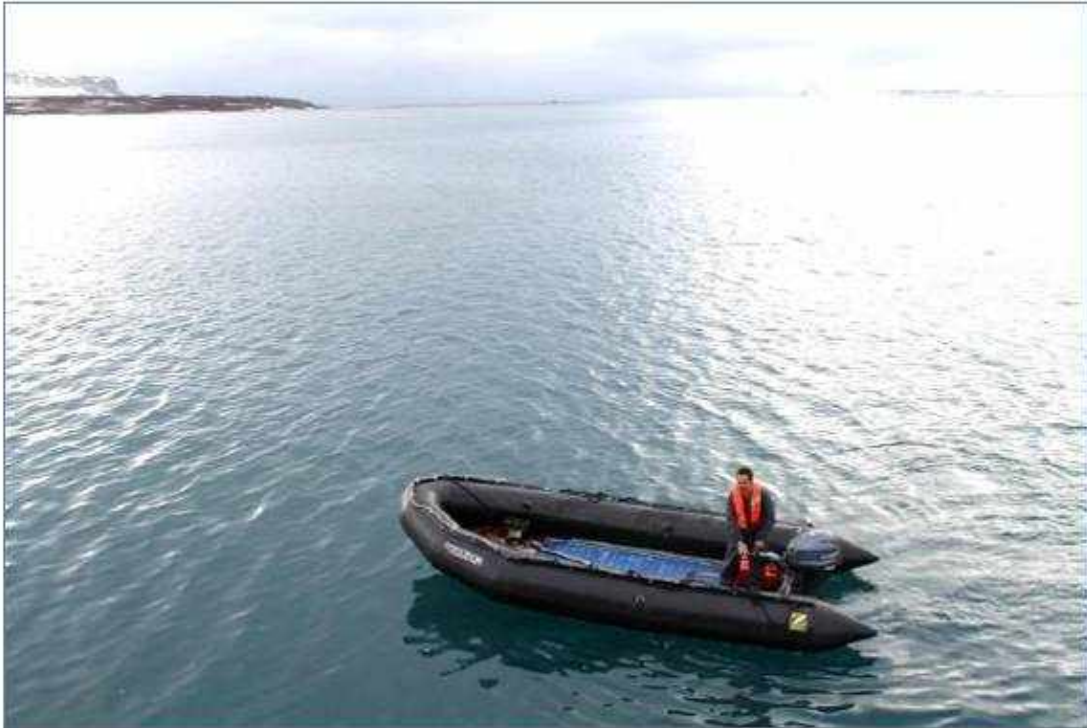
FIG 12: Zodiac «Poseidon» som havarerte i Fjortende Juli-bukta.

- 4.2 The zodiac craft Poseidon, a MK V HD model constructed of black Hypalon fabric, was considered by the operating crew, to be fit for passenger operations. The systems that were put in place by Quark Expeditions provided for the completion of a detailed set of pre-departure safety checks for all key components prior to operation. There is no evidence to suggest therefore that this accident is attributed to craft deficiencies.

- 5.2 In accordance with the Quark company procedures, the operational condition of the zodiac craft that were in use on board the *Sea Spirit* was satisfactory. There was no evidence to suggest therefore, that any technical malfunction or craft deficiency on board the zodiac 'Poseidon' contributed to this accident.

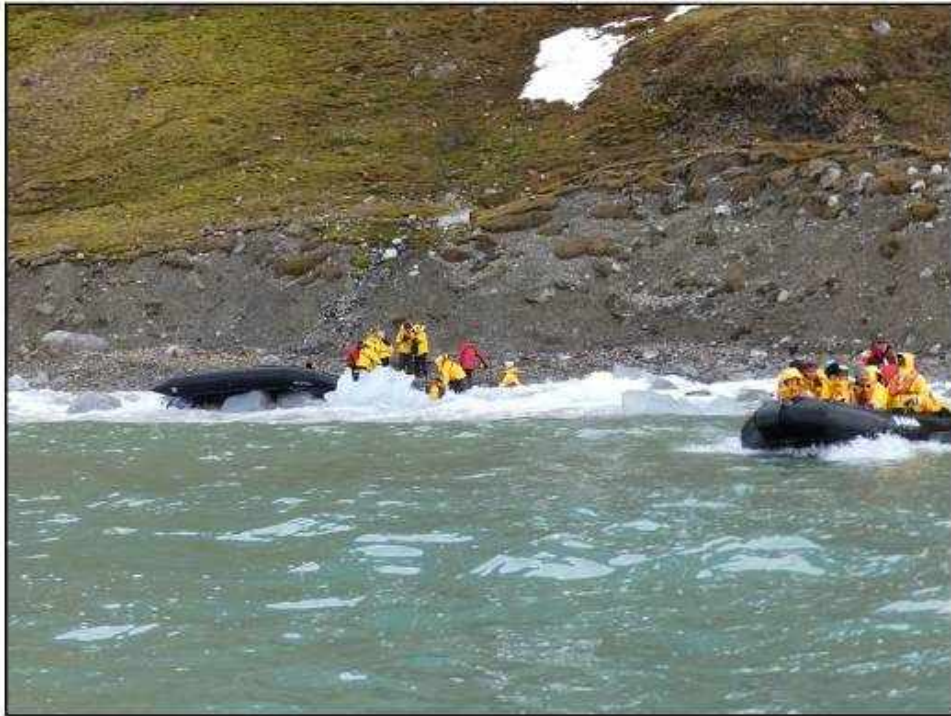
FIG 2.3: Filnavn P6170728. Tatt 17.06.13 09:59 (10:59).

- 4.12 It is also noted from one statement that when assistance was dispatched the medical personnel were unable to land on shore due to the heavy swell. This information is consistent with a hypothesis that there was a rapid increase in sea state. However, there is no objective evidence to support this and the photographic evidence in **Appendix 1** does not indicate a heavy sea state.
